# RMS OVERHAULS AXI OFS MACHINE FOR PETROCHEMICAL CUSTOMER

*By James Wieder and Jeff Lovelady*

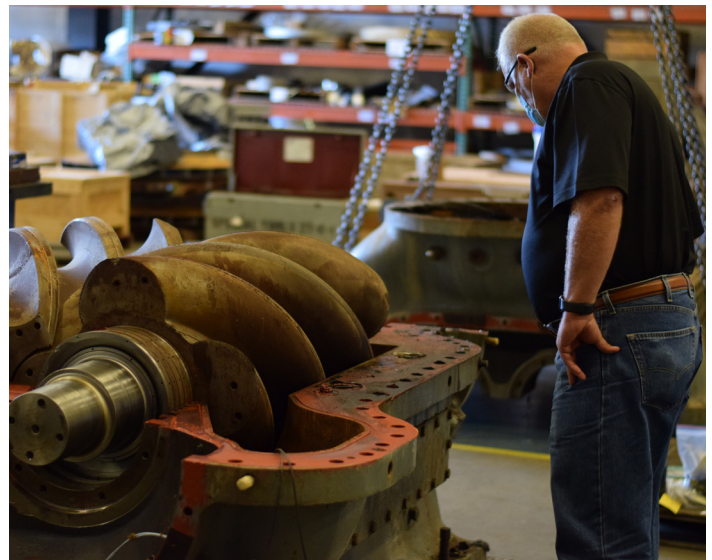
The full inspection revealed several repair opportunities. The RMS team identified a water leak at the split line seal between the cooling water connection between the upper and lower halves as the main cause of the failure. Water entered the lube oil system, which

negatively affected the oil's ability to properly lubricate the bearings causing the steam turbine to trip leading to a plant shutdown. At the split line, RMS identified, corrosion at the O-ring location, a Teflon ring with no backing support, corrosion on mating seal surface on the upper half joint face, and Oxidation path on horizontal joint clearly showed the leak path to discharge end oil drain.

With the inspection work completed, the RMS team got to work on the repairs required to get this Dresser-Rand Axi 630HS165 Oil Free Screw Compressor back into service. First, the O-Ring joint was opened up so the RMS team could create a counter-bore for (4) steel disks to be inserted into both upper and lower half casings. The Steel disks were inserted into the counter-bore in the casing halves and seal welded into place. The lower half disks were machined flush with horizontal joint and the O-Ring groove was machined into the lower half disks. Finally, the upper half casing was recut to eliminate corrosion to the seal surfaces around the O-ring seat.
