# SOLVING A DESIGN FLAW THROUGH INNOVATIVE ENGINEERING ON A NASH HP-9 COMPRESSOR

By Robert Tabb, General Manager • Allan Mathis, Principal Engineer

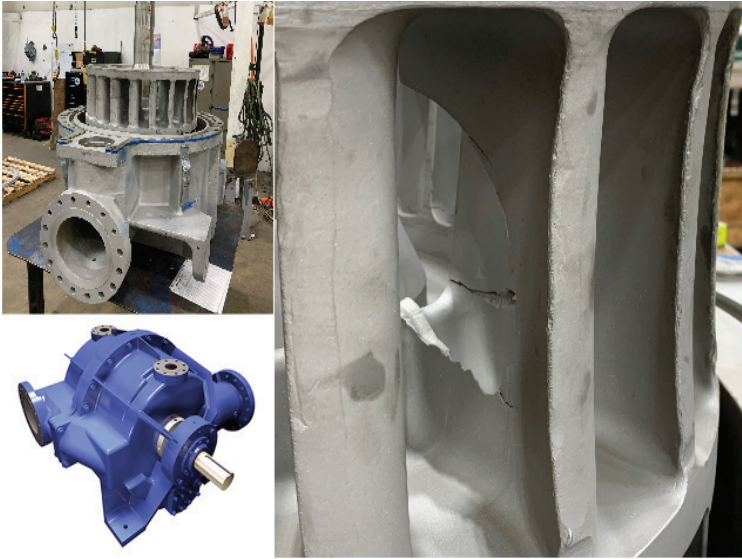
The initial inspection started with a detailed visual inspection, photos, and critical measurements. The compressor was received locked up. With the split line bolts loosened, the team was able to separate the casing halves to expose the damaged impeller and distribution cones. The team dry stacked the compressor to measure the total float. Extensive damage was noted on the DE of the impeller; OD of the DE impeller blades indicated severe FOD damage and visual cracks. A large portion of a single vane catastrophically failed and remnants of the blade material were found at the bottom of the NDE case. The blade fragment lodged between the eccentric portion of the case and the impeller, causing the blade damage on the DE impeller vanes. Improper rotor running position and facial misalignment of the distribution cone caused the contact rubs on the DE of the impeller and the DE distribution cone taper, which locked up the impeller. No damage or cracks were noted on the NDE side of the impeller or distribution cone.

Vane cracks all emanated from the inlet side of the vanes and progressed outward toward the discharge side. All of the components were blasted clean, PMI'd, and tested using NDT methods for a detailed report of the damage.

An FEA study had been performed by a third party to identify possible blade failure modes in previous incidences of blade failures common to these compressors. FEA analysis confirmed process spikes and contact rubs with the distribution cones can excite the natural frequency of the impeller vanes, initiating a low-cycle fatigue crack which can progress to a ductile failure. The FEA analysis and identified high stress point correlated exactly with location of the vane cracks found on this rotor. The team was also able to confirm through frequency testing that the customer's forged impeller had almost identical natural frequency responses as their cast impeller.

NASH (the OEM) and the customer had replaced the original cast impeller (316 SS) with a forged impeller (AL6XN material). The forged design was a duplicate of the original cast impeller, which contained the same inherent design deficiencies. In the end, the forged impeller suffered the same failure mode as the cast impeller.

To correct this design flaw, the RMS Engineering team will work on a joint project with the customer to redesign the high stress areas of the impeller to avoid these problematic frequency responses going forward. RMS engineering team will confirm the redesigned impeller vanes with additional FEA analysis. Along with a redesigned impeller, the RMS team will correct the compressor's misaligned case components, repair and upgrade the impeller distribution cones, eliminating costly new replacements.
