INSPECTION AND OVERHAUL OF A CONMEC FEX-97HT FCC EXPANDER

By Don Shafer

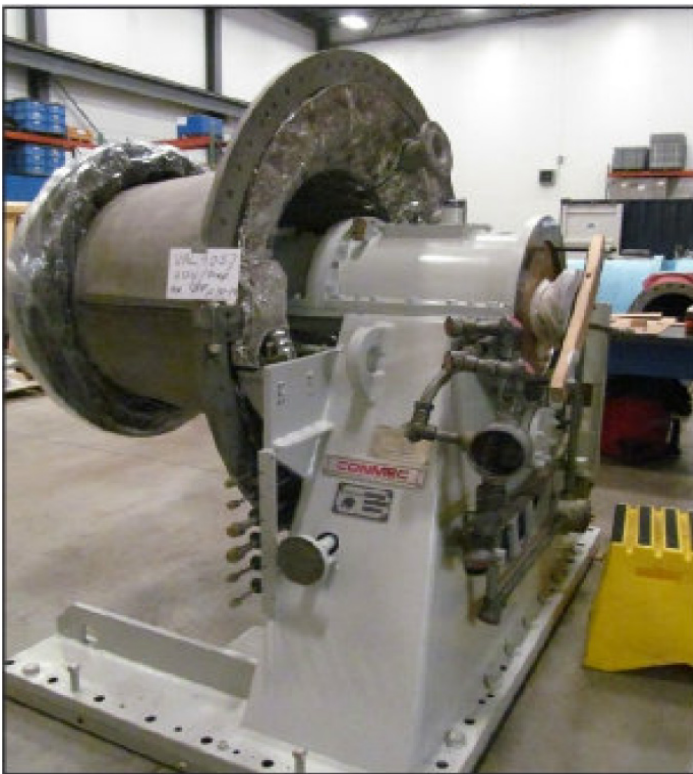
Rotating Machinery Services was contracted to perform a complete inspection on FEX-97HT Rotor, Bearing and Seal Assembly and Rotor Assembly that was removed from service. These sub-assemblies had been removed from service after a 5 year operating campaign. As per the normal RMS procedure all of the components were dis-assembled, cleaned and inspected. All critical dimensions and runouts were documented and used to develop the repair workscopes. The key structural welds and machined surfaces were non-destructively tested to ensure the integrity of the components.

Figure 1: RBSA Rebuilt

All of the remaining repair workscopes were completed on this basis. All of the required Rotor, Bearing and Seal Assembly components were refurbished or replaced with new. All new joint fasteners, new equipment health monitoring instrumentation, new tubing and insulation were provided. The rotor assembly was installed and all critical clearances were brought into tolerance and recorded prior to shipment. RMS completed the assemblies as promised and they arrived at site as required by the customer.

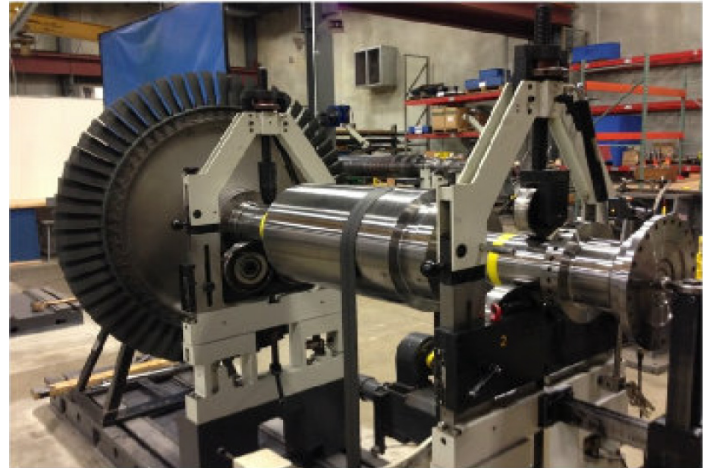
A complete inspection was also performed on the Rotor Assembly. The rotor blades were determined not to be suitable for reuse. RMS provided a replace-in-kind set of 63 rotor blades with the existing airfoil geometry. This required a modification to the RMS existing Ex38 blade casting tooling and requalification

Figure 2: Re-bladed with RMS Ex38CO Blades

of the fixed process for this set of new blades. This modification now allows RMS to provide a full range of E-138, Ex38, Ex38ER, Ex38CO, FEX-97, FEX-97HT, FEX-107 rotor blade castings. The rotor disc was inspected and blended to remove minor erosion cutting on the tenons and prepared for re-assembly. All of the remaining rotor assembly components were inspected and deemed suitable for re-assembly. The completed rotor assembly was low speed balanced and high speed balanced.
