POWER TURBINE CRACKING AT THE ANNULUS MOUNTING FLANGE

By Robert Klova, PE

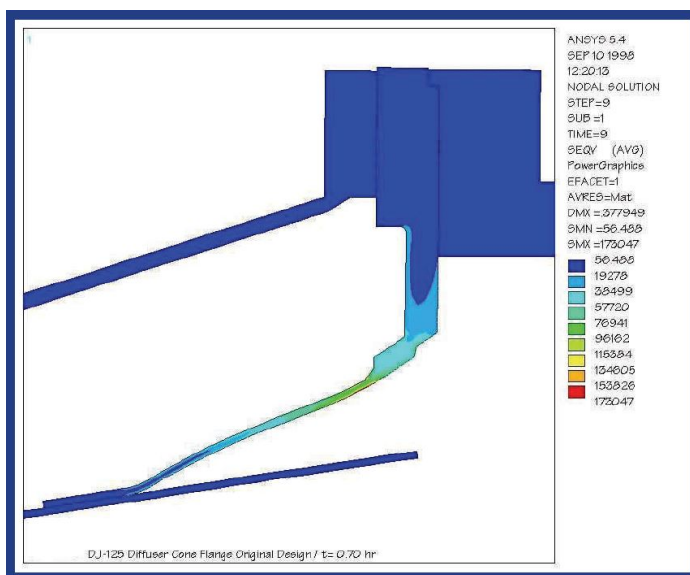
To determine the cause of the cracking, RMS performed a finite element analysis (FEA) to determine peak stresses, which, it was determined, are caused by high transient thermal loading during start-up. These thermal stresses are caused by the rapid heating of flow-washed surfaces, being constrained by the relatively cool Annulus mounting flange. As shown in the stress contour plot, peak stresses were calculated to be 175,000 psi. Since the part is manufactured from AISI 304 stainless steel, which has a yield strength at temperature of under 30,000 psi, cracking at the peak stress location was predicted to occur with very few thermal cycles (start-up and shut-down).

Figure 2: Original Design Showing Extreme Stresses in the Area Where Cracking Occurred

RMS's solution to the problem was to separate the hot flow-washed section of the annulus from the much cooler mounting flange. Axial expansion pins were employed to maintain concentricity of the duct. By doing so, thermal stresses were reduced to 20,000 psi. RMS provided three new Inlet Annuluses to our customer with the redesigned geometry. The design has been very successful, and completely eliminated the need for weld repair since the new ducts were placed in service.

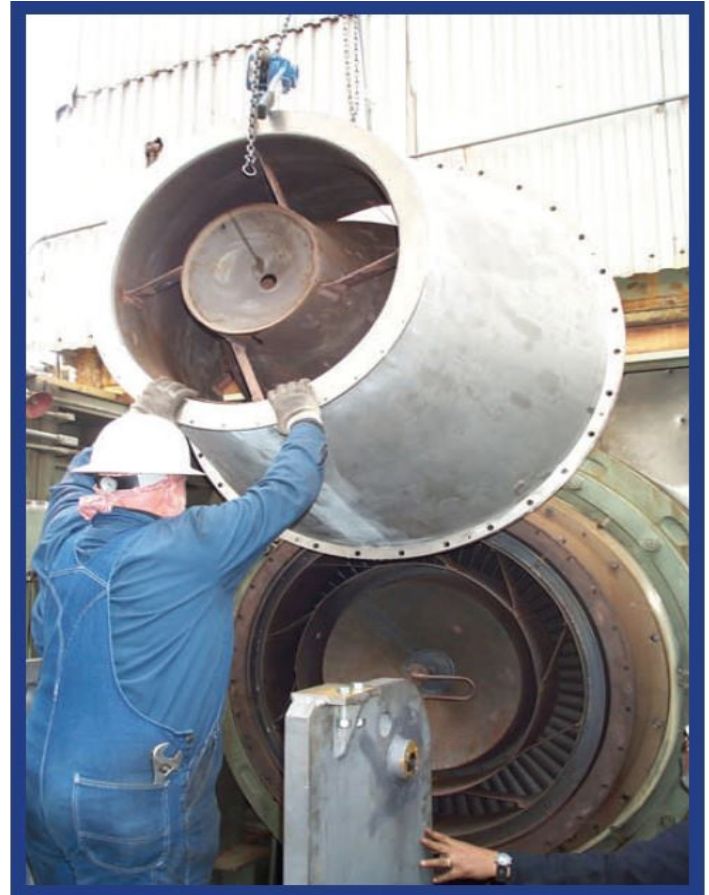
In 1998, RMS was contracted by a major US natural gas company to correct a chronic cracking problem on their Dresser-Clark DJ125 power turbine inlet ducts. The component, called an Inlet Annulus, directs flow from a GE LM1500 gas generator into the DJ125 aero derivative power turbine. Our customer experienced cracking at the Annulus mounting flange which required weld repair on a yearly basis.

Figure 1: Inlet Annulus Being Installed in the Field

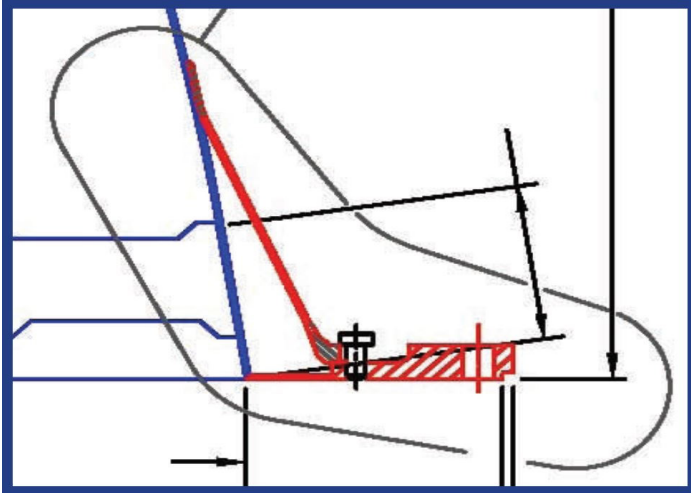
After a number of years of operation, however, cracking began to occur in around the expansion pins that align the hot duct section to the mounting flange. This has been managed by stop-drilling these cracks when they

Figure 3: First Redesign Showing Expansion Pin

are found. RMS recently recommended a redesign of the mounting flange to our customer, to eliminate this cracking, since their turbines are now expected to continue in operation for another five to ten years.

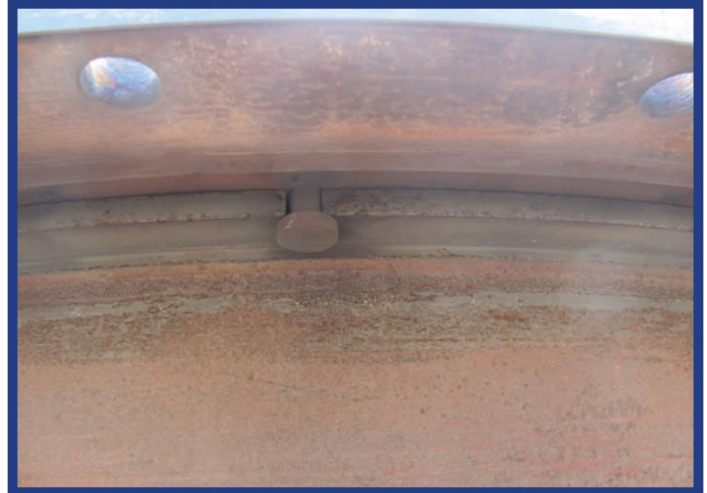
Figure 4: Expansion Pin During Routine Inspection
