RMS TOTAL TEAM EFFORT SAVES DR61 POWER TURBINE USER MONTHS OF DOWN TIME

By Robert J. Klova, P.E.

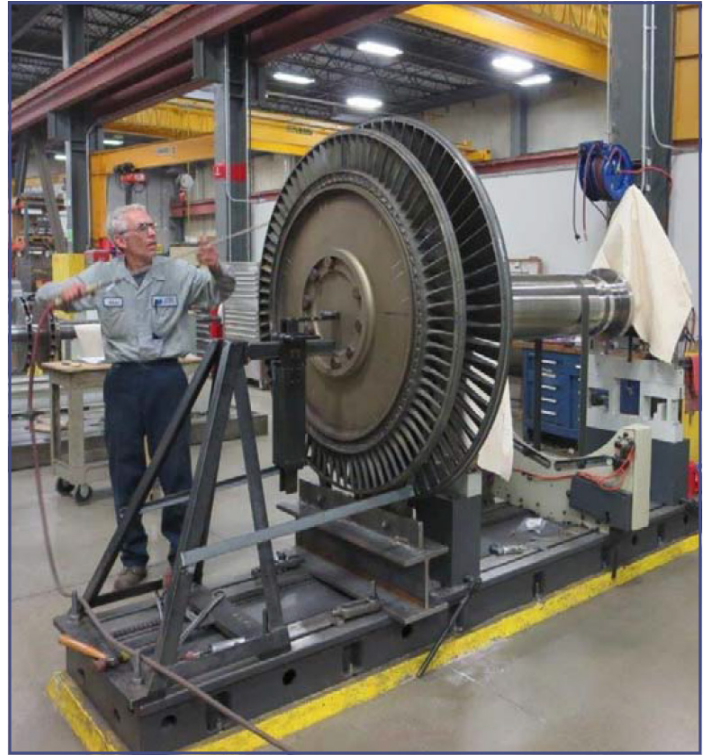
Figure 2

The problem was caused by a heat shield that came free from its mounting point behind the second stage disk, heavily rubbing the disk and blades, and destroying the heat shield. The customer needed a new heat shield in the shortest possible timeframe. With our strong supplier relationships, RMS' seasoned Purchasing department was able to source a new Inconel 600 fabricated heat shield in one weeks' time.

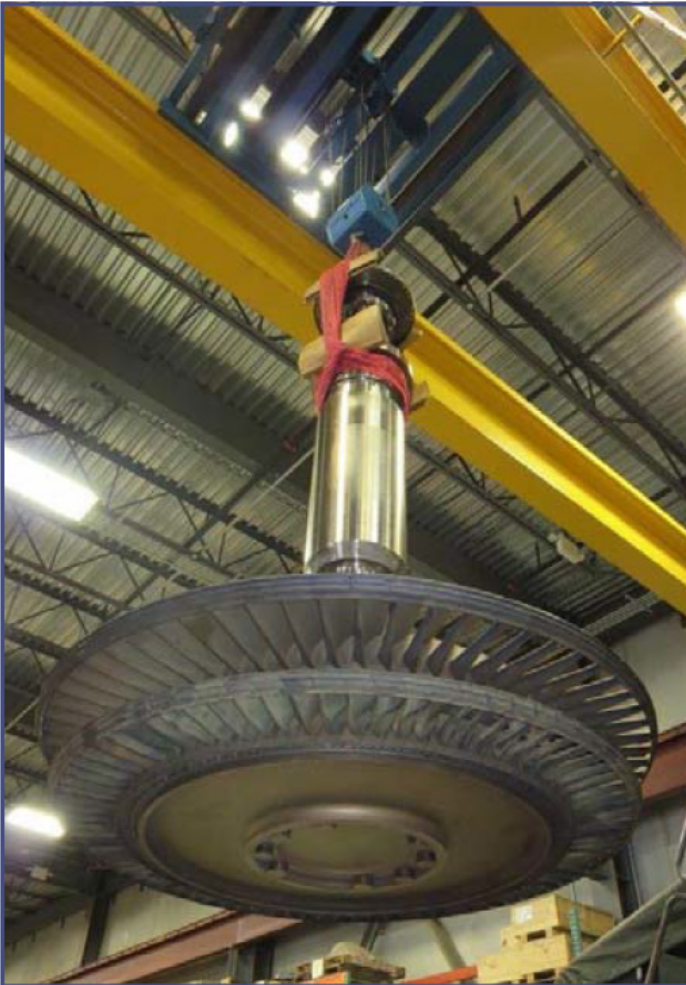
Figure 1

This would have been just in time to reassemble the power turbine - but that was not to be. Inspection of the removed rotor by RMS' on-site engineer revealed that the blade lockwire tabs were rubbed so heavily that blade fixity in the disk could not be guaranteed. RMS recommended a partial shop overhaul of the rotor, including the repair and use of second stage blades from a damaged rotor stored on-site. Based

upon site inspection of both rotors, RMS put together a plan and estimate to perform a four day repair in our shop, working around the clock.

The rotor was completed in the promised eight shifts, and shipped back to the field, in spite of several unanticipated findings. Primary among these was the extensive work required to remove the rub damage from, and save, the Waspaloy second stage disk – an expensive and long-lead part. Hardness readings revealed a softening of the disk material along nearly the entire disk aft surface. Without experienced engineering review, and working hand-in-hand with skilled shop personnel to carefully remove material and monitor hardness levels, this disk would not have been
