RESOLUTION OF SPEED SENSOR ANOMALY

By Tony Rubino, P.E.

A refinery FCCU expander recently encountered unexpected overspeed trips during post turnaround startup. Both the speed pickups and the rotor shaft were new. The expander train start was initiated several times and consistently tripped due to false overspeed indication. Replacement of suspected faulty probes did not resolve the problem.

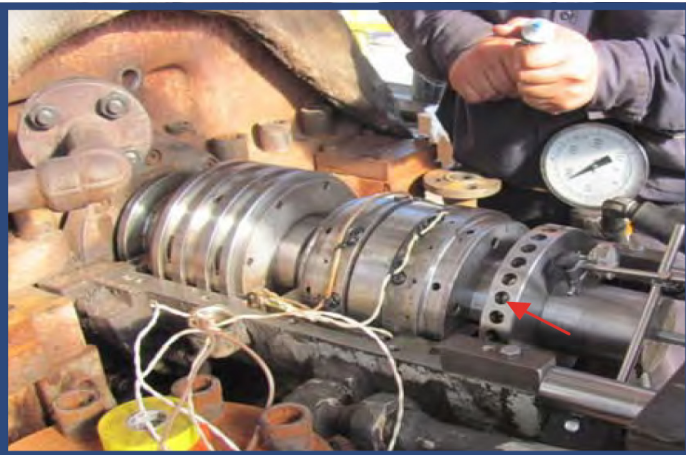
Figure 1: The red arrow points to the turbine speed probe targets. Note the spacing of the targets relative to the target diameter.

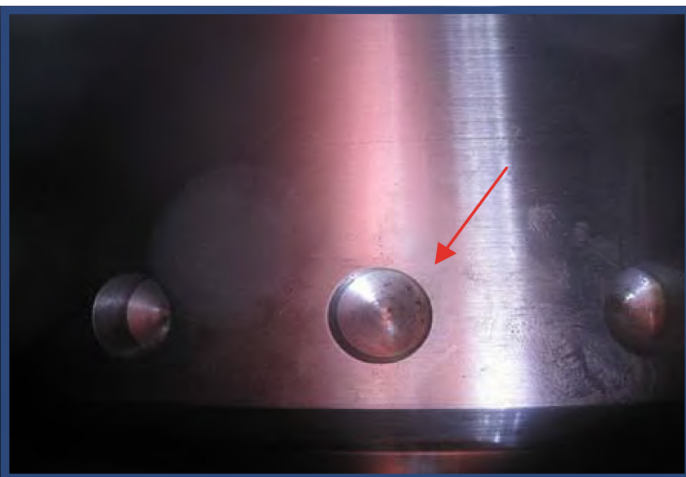
Figure 2: The red arrow points to the expander speed probe targets. Note the expander targets are more widely spaced than the turbine targets.

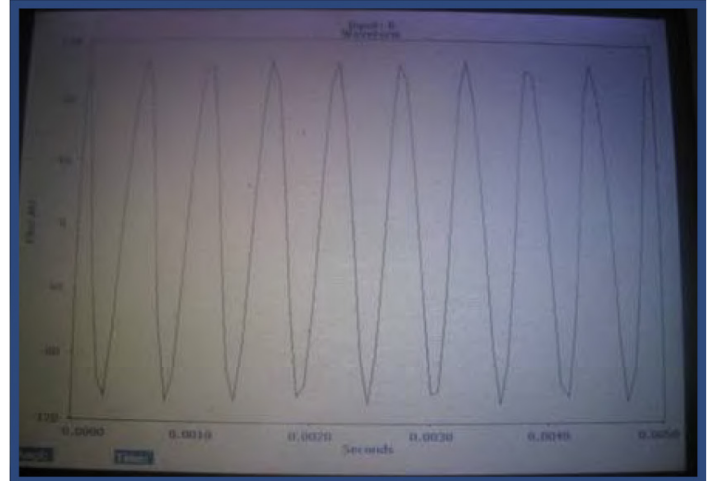
Figure 3: The turbine sensor waveform from an oscilloscope is almost perfectly sinusoidal due to the configuration of the target. This waveform was taken at full speed (36,000 rpm). The wave form has similar shape but smaller magnitude at slow roll.

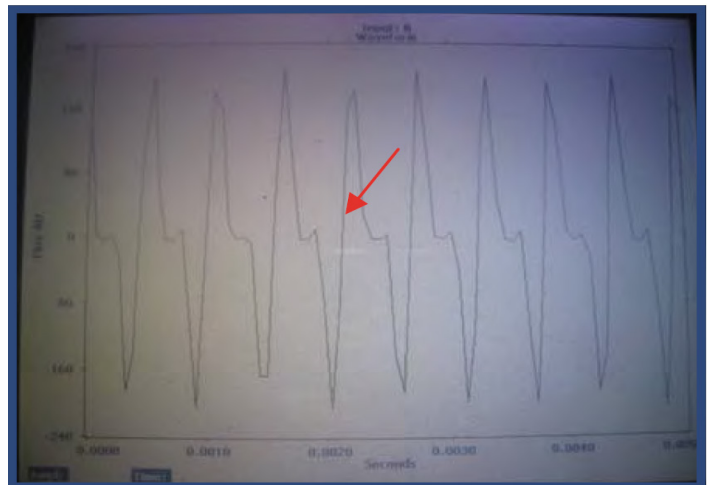
Figure 4: The expander wave form exhibited a knee or shoulder due to the spacing of the targets. The short peak at the end of the knee (see red arrow) proved problematic at elevated speed.

The understanding of three key items led to the resolution of the problem. First, the output of the sensor was a function of target surface speed and gap from the probe to the surface. Higher rotor speed and smaller gap both increased sensor output voltage. Second, increased sensor output amplified the noise as well as the desired target signal. A very sensitive monitor would count the noise as well as the target signal. Third,

attenuation of the probe output greatly reduced the influence of the harmonic noise. Accordingly, a 1k Ohm resistor was added to the control circuit and the probe to surface gap was increased to attenuate the signal and to minimize the potential for electrical ringing. The final waveform and spectrum are show below.

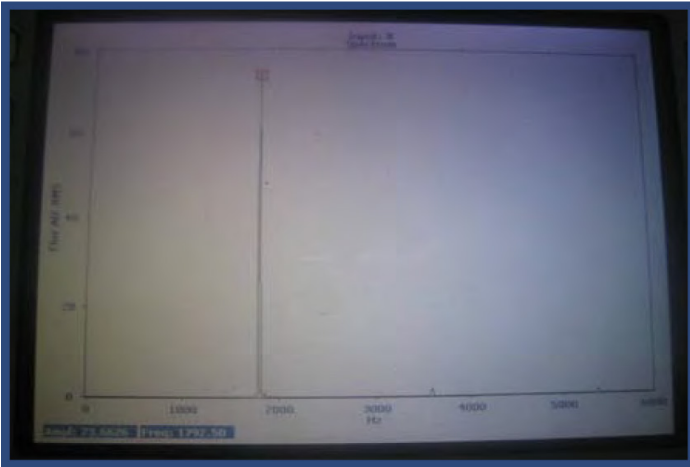
Figure 5: The turbine sensor spectrum was very clean exhibiting essentially only the target frequency of 1,800 Hz (30 targets X 60 Hz) at 3,600 rpm.

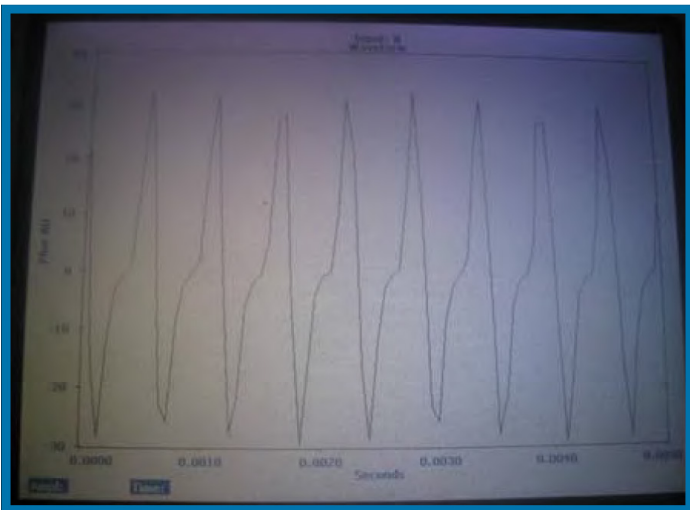
Figure 7: The attenuated signal shows almost complete removal of the "knee".

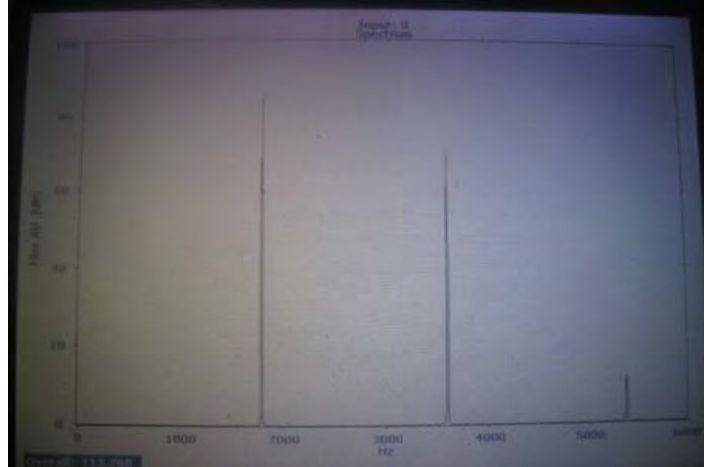
Figure 6: The expander sensor spectrum was noisy exhibiting the target frequency as well as a strong 2X harmonic.

The root cause for the phenomenon is still unknown. A possible difference between the two rotor shafts is suspect and will be investigated during the overhaul.

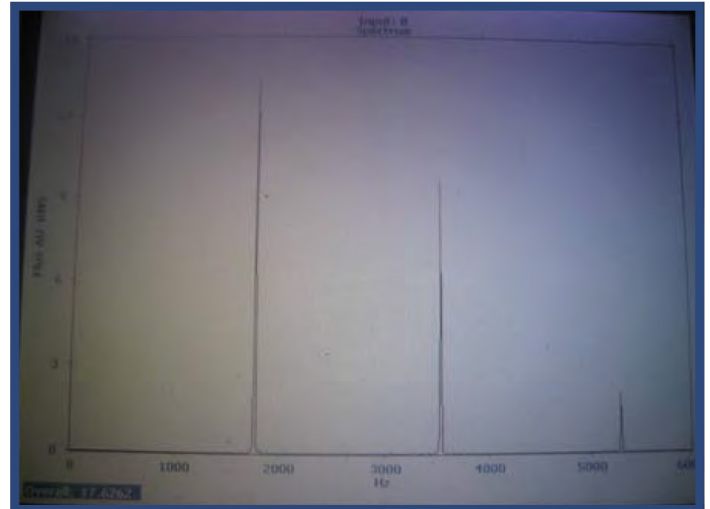
Figure 8: The harmonics are still present but sufficiently filtered to not affect the speed sensor monitor.
