# STEAM TURBINE DOVETAIL STYLE SHROUD INDICATIONS

By Scott MacFarlane

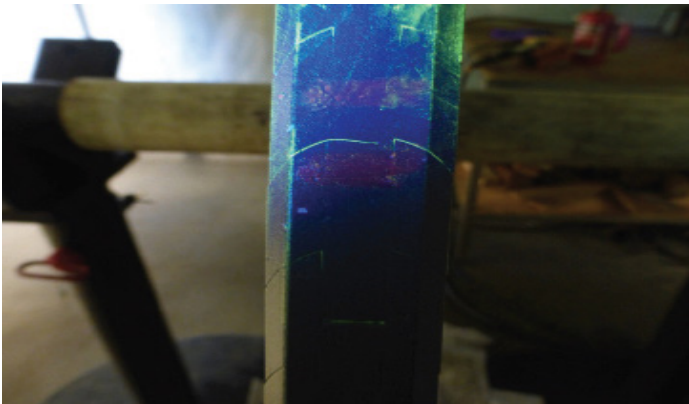
Figure 1

The indications in the rolled-in bands occur at the edges between adjacent blades. A photo of such an indication is shown in Figure 1. The inception of these

The most effective means of preventing these cracks is to stabilize the blade tips during the assembly and machining process which leads to a superior wheel assembly without the introduction of pre-cracks in the bands. There are different means of accomplishing this task which, RMS has developed its own proprietary process.

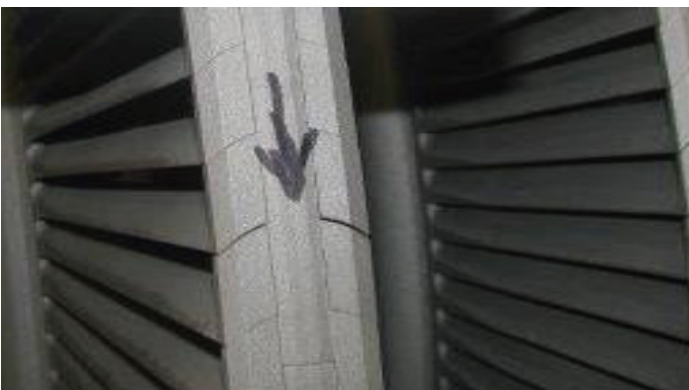
Figure 2

indications is due to relative displacement between blades resulting in high stress and cracking in the band (Figure 2). It is known that the initiation site may be formed during the installation of the blades when the shrouds are machined after installing the bands. Tool pressure during machining has been observed

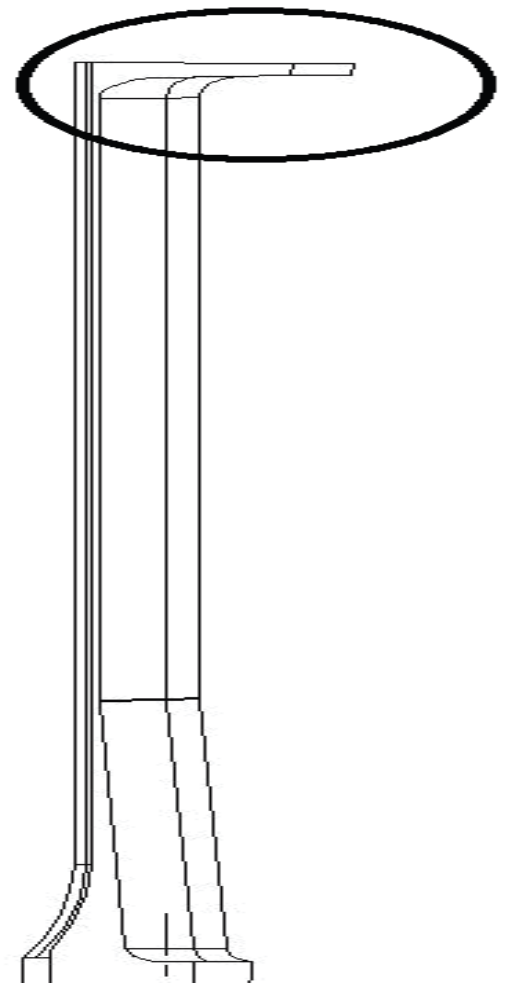
Figure 3

to deflect the integral shroud blade tips which are cantilevered from the airfoil tip (Figure 3). The problem is more significant on later stages where longer blade lengths reduce structural stiffness.

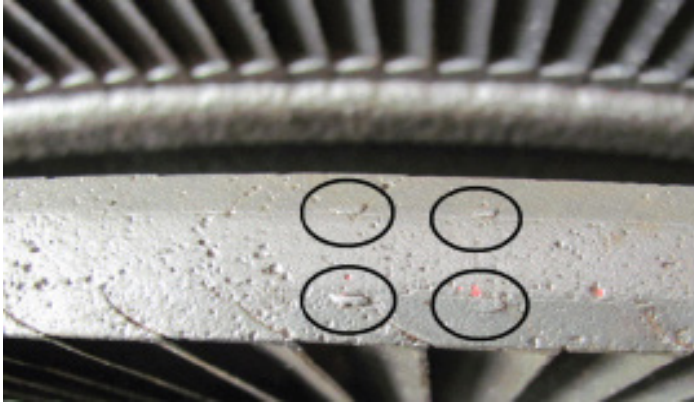
The other type of crack-like indication shows up in the blade parent material at the edge of the dovetail slot next to the adjacent blade. Figure 4 shows the raised edges where the material has cracked and Figure 5 shows areas where that metal has broken away leaving a void.

RMS has determined through structural analysis that these indications in themselves are not an immediate danger to the rotor blade operation. Depending on the

extent, there may exist sufficient parent material in the remaining dovetail to adequately prevent individual blade movement. Many of these indications have been observed but there has been no documented failure as a result.

Regardless, any observed cracking in the dovetail style shroud configurations should be addressed to reduce the chance of further damage or machine failure.
