STEAM TURBINE ENGINEERED REPAIRS

By Tim Coull

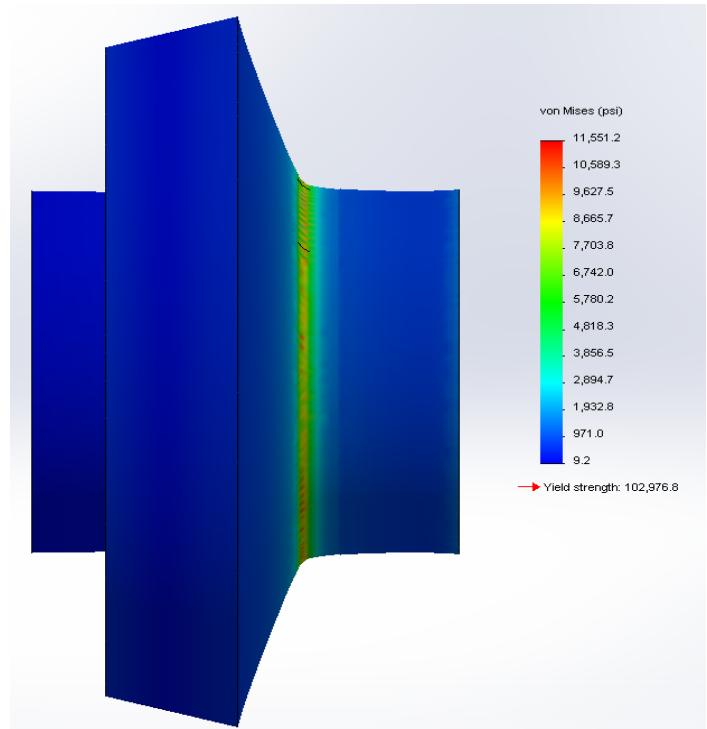
RMS conducted a preliminary finite element analysis (FEA) using SolidWorks SimulationXpress. A 3-D model was created using real geometry less .100" material removal from the thrust-collar, and an axial load applied using the ultimate load for standard bearings of similar size. Preliminary analysis showed that peak stresses were well below yield with a design factor of about 7.5.

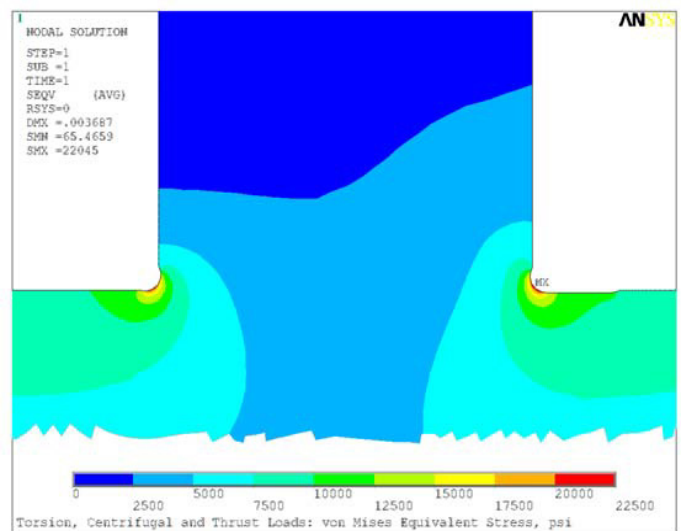
A more in-depth ANSYS 2-D axisymmetric model with out-of-plane loading capabilities was built to get higher resolution in highly stressed areas. A base-case model confirmed the SolidWorks results within a reasonable amount of accuracy. Another model was built

to account for centrifugal and torque transmission loads, since the coupling on this machine is on the thrust-end. These results obviously showed higher max stresses than the base case, though still well below yield, with a design factor of about 4. These analyses clearly showed that further material removal would not pose a problem during operation.

Significant material removal obviously requires manufacturing a large shim to keep the bearing against the collar. However, this plus a single machining operation is clearly a more attractive option than three machining and two welding operations, plus the possibility of significant shaft distortion. With a little forethought, abandonment of presuppositions, and utilization of modern technology, RMS leveraged its experience to deliver reliable machine repair options with our customer's best interest in mind.
