RECENT COMPRESSOR ROTOR OVERHAULS

Rotating Machinery Services, Inc.

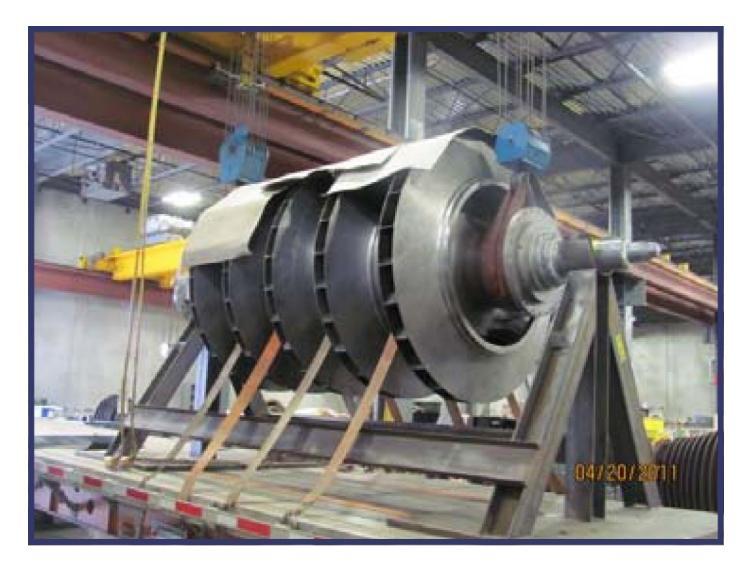
The inspection and repair of these rotors is no easy task as they are bulky assemblies. The largest impeller diameter is approximately 65", the overall rotor length is nearly 13 feet, and the estimated weight is 19,000 lbs. Regardless, RMS possesses the shop capability to refurbish these rotors for continued service.

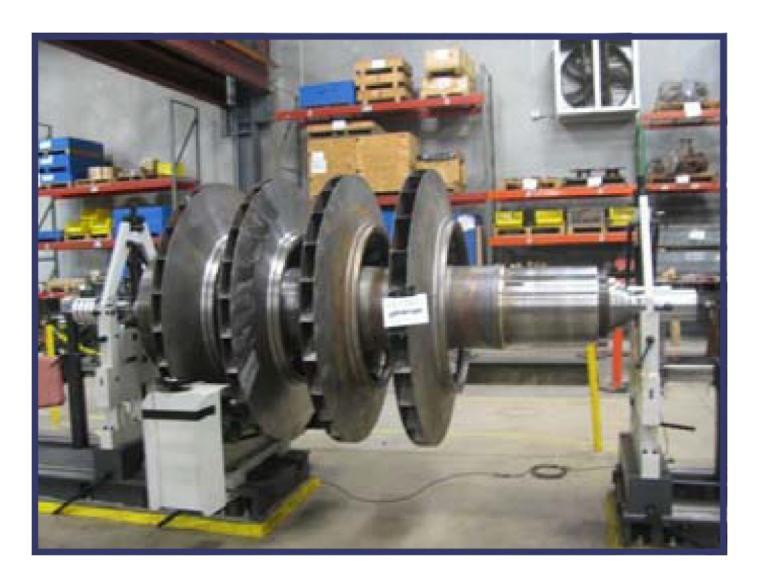
by the thickness of the rings. These rings are often replaced due to deformation from the shrink fits and / or shearing via thermal ratcheting—the tendency for parts to move axially on a rotor due to thermal growth.

The bores of the impellers, sleeves, and balance piston are evaluated for roundness and concentricity. If determined unacceptable, the bores are reworked via machining to reestablish concentricity. Another typical repair to these rotors is re-riveting the impeller blades. Rivets that warrant replacement include rivets with eroded, cracked, or voided heads. RMS also has encountered these rotors with riveted impellers replaced with fabricated impellers. Once all repairs are completed, the rotor is reassembled and balanced to RMS and API 687 criteria.
