COUPLING BUCKLING ANALYSIS

By Christopher Sykora

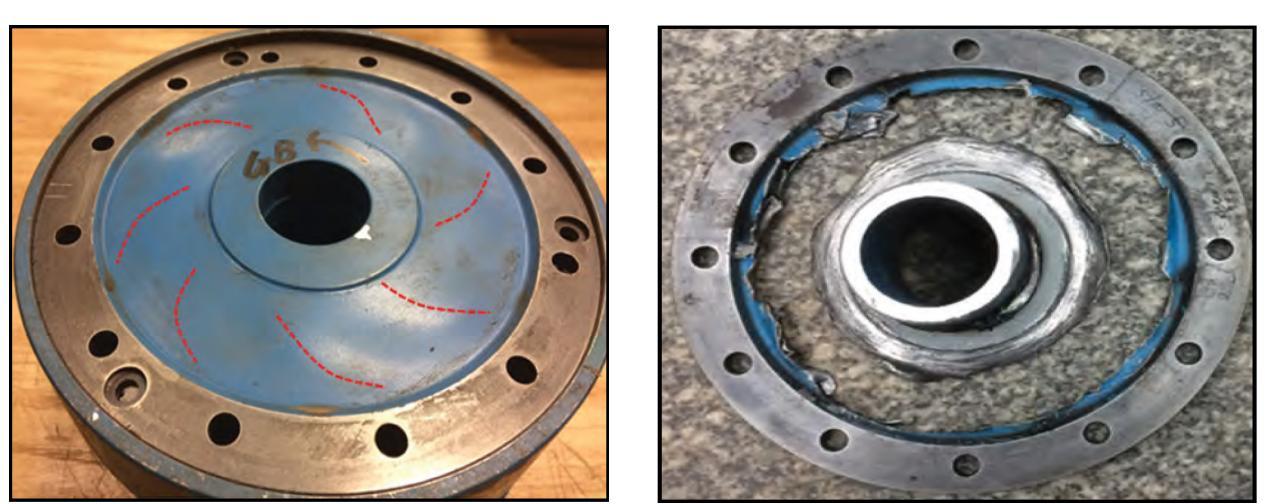
For this RCFA, the couplings were inspected for cracks and the material tensile strength and ductility were determined. None of these steps produced any evidence of material defects that could have been the cause of the failure. So a finite element analysis (FEA) was used to investigate the buckling capability of the as-built coupling. This served as an independent check on the coupling manufacturers stated design limits. The analysis geometry was based on a detailed Faro arm inspection of the as-built coupling with the minimum

Figure 1: Spiral Buckled Coupling (Left) & Completely Failed Other End (Right)

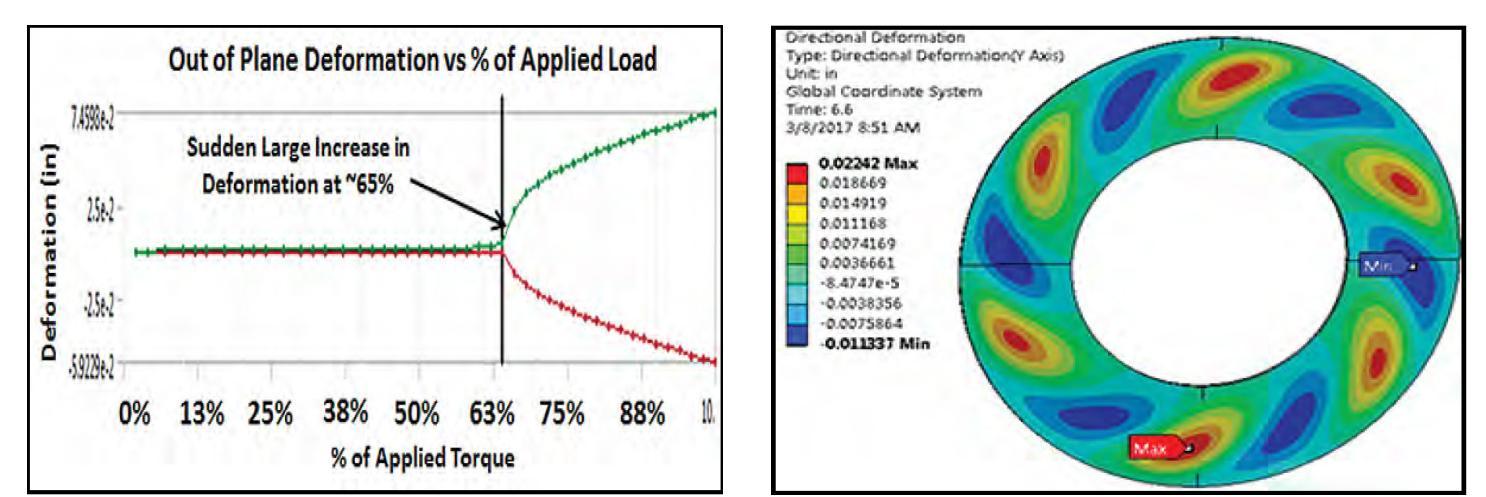
The buckling capability of the coupling was predicted in the FEA by doing a nonlinear structural analysis with the torque load incremented in many small steps from zero to high load. While this analysis technique increases computational time due to the many small steps, it is the most accurate method of predicting the buckling. When the coupling structure reaches the load at which buckling begins, there is a significant increase

in the slope of the graph of out of plane deformation vs applied load. Figure 3 shows the resulting graph from the analysis and the associated spiral pattern buckling deformation. The RMS analysis predicted buckling load capability very similar to the design rating specified by the coupling manufacturer. Subsequently, the manufacturer performed a static load test (also incremented in small steps) on a spare coupling that would further validate their original design predictions. Buckling occurred in the test at a slightly higher load than in the prediction since the coupling web thickness was closer to nominal than the minimum thicknesses used in the analysis. This advanced analysis was a good opportunity for RMS to further exercise its broad analytical capabilities. Ultimately it was determined that the electric motor must have been producing a higher peak torque than was previously understood. Therefore, RMS recommended a higher torque rating value for the next coupling purchased. The higher rated coupling was installed and survived a unit startup test without any damage at all. It was disassembled, inspected, reinstalled, and the compressor train has been operating successfully ever since.

Figure 3: Deformation Graph (Left) & Buckling Shape (Right)
