HIGH TEMPERATURE NITRIC ACID EXPANDER INLET SCROLL DISTORTION

By Sydney Gross, Director - Steam Turbine Engineering

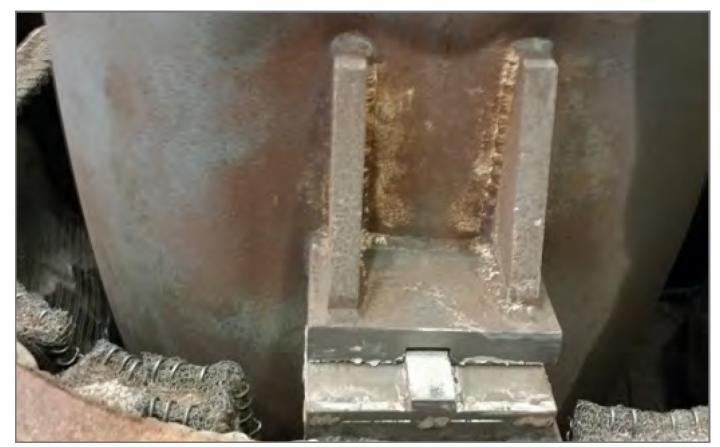
In practice, these alignment features frequently bind due to misalignment, tight clearances, component distortion, corrosion, etc. and prevent the scroll from freely expanding resulting in distortion and cracking of the scroll and affecting alignment to the rotor.

Binding can occur relatively quickly during the operating cycle depending on the severity of the cause. The cracking is sometimes exacerbated by embrittlement of the material from thermal aging. Because this is a common problem, time during the overhaul should be allowed for repair of the scroll.

Figure 3: Scroll Distortion from Keyed Support Foot

Repair often includes removal of the old key feet and pin bosses and patching in new or repaired parts. Reinforcing the shell of the scroll in the area of the attachment has been effective in preventing excessive distortion as well. Casings that have experienced embrittlement can often be rejuvenated through a solution anneal heat treatment. Embrittled material can be impossible to weld because cracks will propagate from the heat affected zone so solution treatment should be done first. Aside from welding difficulties, embrittlement can be identified through metallurgical

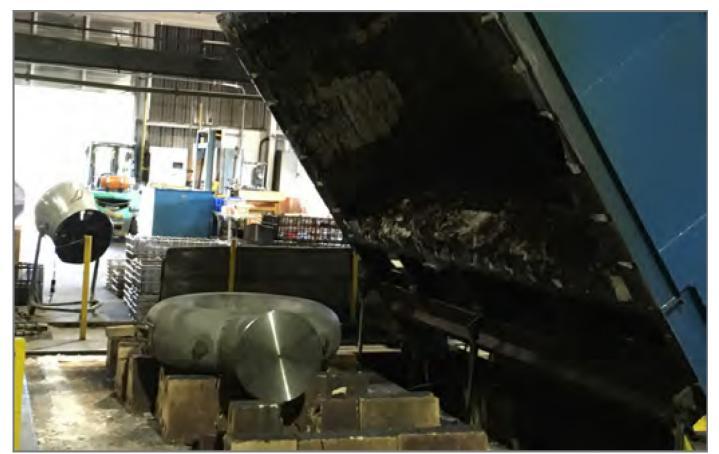
Figure 5: Scroll in Oven for Solution Anneal Treatment

analysis. The thin wall construction of the scroll makes bracing during heat treatment critical in preventing and correcting distortion. Remachining of the feet and nozzle fit will be necessary after weld repair.

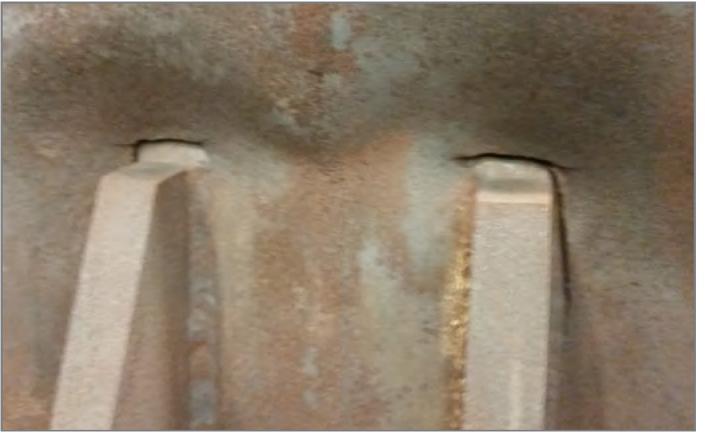
Figure 4: Scroll Cracking from Keyed Support Foot

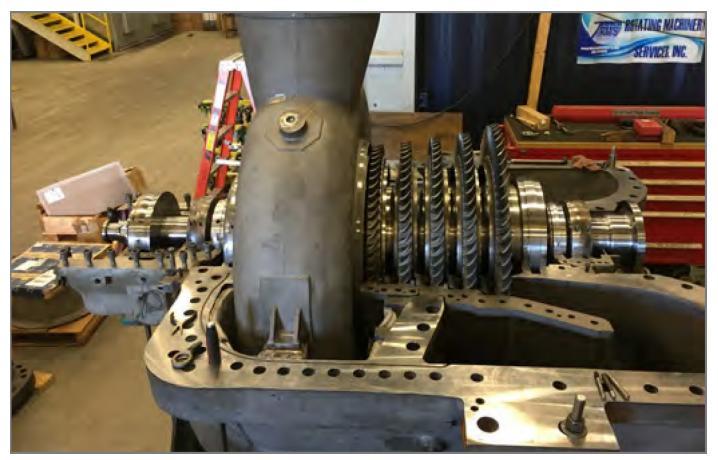
Figure 6: Assembly of Repaired Scroll with Reinforced Features

Prevention of in-service distortion is not always possible. However, by ensuring adequate design clearances, using appropriate materials and designs in the alignment features and aligning the scroll correctly, damage and distortion can be minimized.
