THE FINISH LINE

WWW.ROTATINGMACHINERY.COM

39TH TURBOMACHINERY SYMPOSIUM

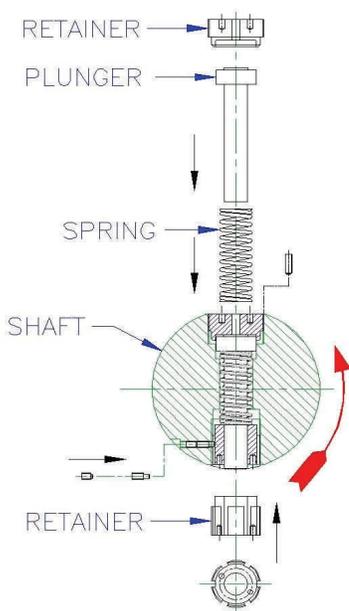
MECHANICAL OVERSPEED MONITORING

In order to achieve trip speed shut down, the trip system has to sense turbine speed and initiate trip valve closing. Trip valves are commonly shut with a heavy spring and are latched open mechanically by system oil pressure. Loss of oil pressure initiated by an oil dump valve then results in valve closing. In a mechanical system, the dump valve is activated directly by mechanical input from a shaft knockout plunger or other centrifugally displaced mechanism. When a high enough rpm is reached the mechanism displaces enough to strike a lever that activates the dump valve. The electronic system senses shaft speed through non-contacting magnetic pick-up sensors. The input goes to the electronic over speed control unit, which initiates the dump valve actuation.

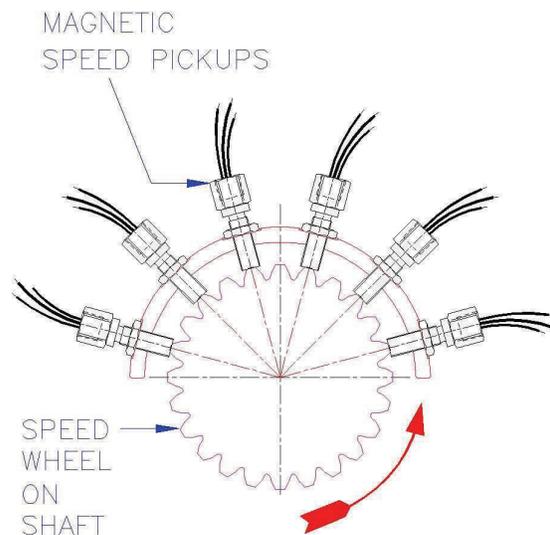
ELECTRONIC OVERSPEED MONITORING

Development of electronic trip systems over the past several years has established their reliability and speed such that they are preferred by most users and manufacturers. Many older turbines have been successfully retrofitted with electronic systems and the mechanical system is either kept as redundant or discarded. One of the primary benefits of the electronic system is that it can be set and tested without actually over-speeding the turbine which is inherently dangerous. This is accomplished by way of a signal generator providing the speed input to the control unit rather than the shaft.

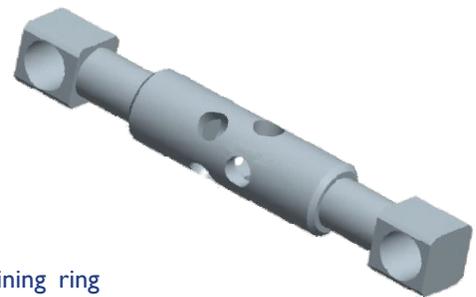
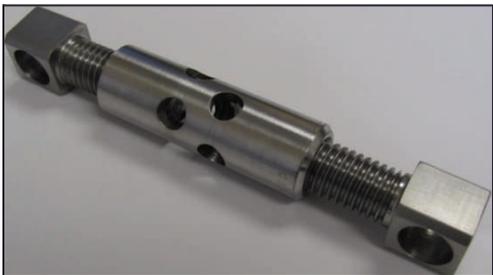
RMS was recently contracted to design and manufacture a set of diaphragm mounting studs for a model RF2BB-30 centrifugal compressor. An on-site visit was planned in order to examine the existing studs during a planned disassembly. During re-assembly of the compressor, it was discovered that the retaining ring, which locates the shear ring in a groove in the compressor casing, was difficult to install. In order for the retaining ring to be properly installed, the shear ring should be expanded from its relaxed shape to allow easy bolting of the retaining ring segments to the diaphragm. RMS used state-of-the-art 3D modeling software to design a spreader tool that will be used to aid in future assemblies and disassemblies of the ring. The design of the tool was based on a turn-buckle that will be bolted to the existing holes in the shear ring and used to either expand the ring during assembly or shrink the ring during disassembly.

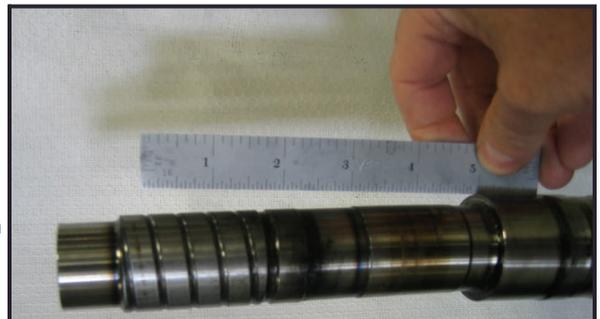
RMS recently completed a root cause failure analysis for a marine diesel engine turbocharger. The units were experiencing catastrophic failures in the turbochargers' compressor section including loss of blading, extensive bearing damage, shaft failure, and subsequent oil contamination of the after cooler. Due to the catastrophic nature of the failures, reconstruction of the failure scenario was impossible due to the secondary damage to the failed components. Preliminary analysis highlighted early detection parameters to allow damaged turbochargers to be removed from service prior to catastrophic failure. Forensic disassembly of damaged (but not failed) turbochargers provided the evidence to relate the root cause to bearing lubrication failure during rapid throttle movements. The short term approach was to limit the rate of throttle movement. A bearing redesign was recommended as a long term solution.

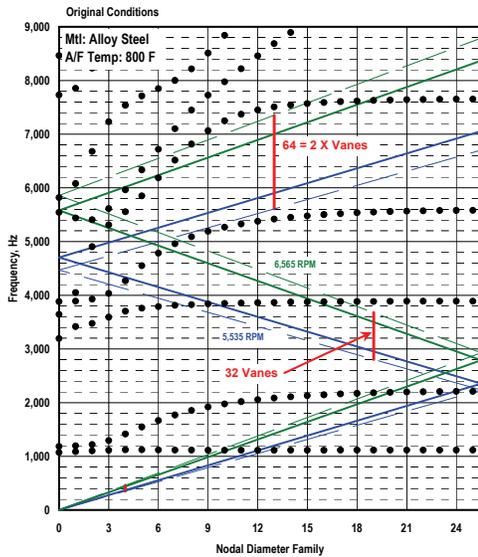
Figure 1 Steam Turbine Bladed Disk (51 Blades) Interference Diagram

Figure 1 is an interference diagram for a steam turbine stage with 51 blades. The “reflection” line on the right side of the diagram is $51 / 2 = 25.5$ nodal diameters. The minimum speed of 5,535 rpm “reflects” at $5,535 * 25.5 / 60 = 2,352$ Hz. The maximum speed of 6,565 rpm reflects at 2,790 Hz. There are 5% separation margins included with the speed lines (one just below the minimum speed and one just above the maximum speed). This turbine stage has 32 vanes just upstream of the rotating blades.

Using the procedure presented in the last newsletter, we locate the 32 vanes at 19 nodal diameters. We then place a vertical line on the diagram at 19 nodal diameters extending from the minimum speed margin line to the maximum speed margin line. We do the same for twice the

There are no interferences on the “Original Condition” interference diagram (Figure 1).

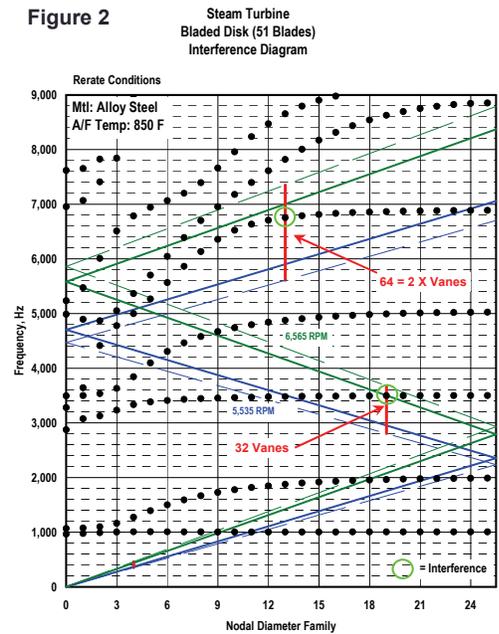
Figure 2 Steam Turbine Bladed Disk (51 Blades) Interference Diagram

The combination of increasing the airfoil length and increasing the airfoil temperature caused the disk and blade natural frequencies to decrease. Figure 2 is the interference diagram for the rerate conditions. There now are two interferences, highlighted on the diagram by bright green circles. One interference is the third blade mode at 19 nodal diameters with the 32 vanes. The other interference is the fifth blade mode at 13 nodal diameters with 2 X the vanes.

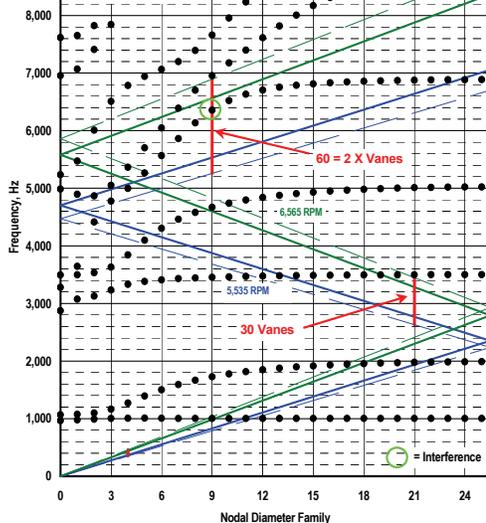
Figure 3 Steam Turbine Bladed Disk (51 Blades) Interference Diagram

Generally, we want to avoid interferences on lower order blade modes, particularly the first two bending modes and the first torsional mode. Therefore, to eliminate the interference with the third mode, we will reduce the vane count to 30. The interference diagram with 30 vanes is shown in Figure 3. The interference with the third blade mode is eliminated but there is still an interference with the fifth mode at 9 nodal diameters and twice the number of vanes.

Higher order modes are more difficult to excite than lower order modes and the stimulus at twice the vane frequency is substantially less than the stimulus at the vane frequency. There is also evidence from the position of the ninth nodal diameter point of the fifth mode that there is limited blade movement (more about that in the next newsletter). Therefore, the remaining interference probably poses little risk to the reliability of the turbine and the changes required to remove the interference would most likely compromise the performance of the turbine.

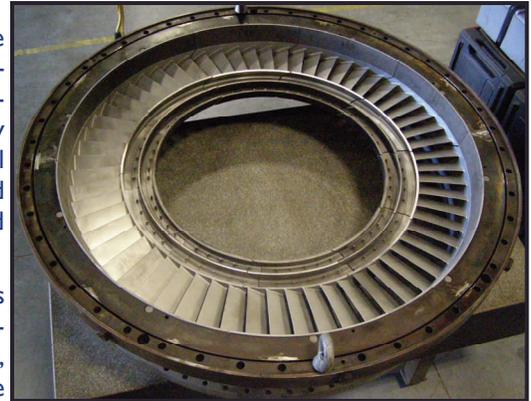
RMS recently completed a major component overhaul of a 1970's vintage GT6I power turbine for a North American gas pipeline company. The project involved the restoration and repair of the two stage-rotor and all high-temperature nickel-alloy stationary components. A new upgraded Incoloy 901 rotor disk was designed and manufactured by RMS to replace the original A286 second stage disk. Components from the customer's inventory of used spares, along with parts from the currently operating turbine, were inspected to determine the most suitable components for repair.

To define the work scope, RMS performed dimensional and NDT inspections of all components. A detailed CAD layout of the turbine was created to insure that proper fit-up and clearances would be maintained during the rebuild, given that components from several sources were used. High-temperature casings were weld repaired, straightened, re-heat treated and remachined.

Stators were weld repaired and remachined to re-establish proper axial clearances to the rotor. All new high-temperature fasteners were supplied. A significant portion of the repair work was performed on a rapid-turnaround basis on components removed after shutting down the operating turbine.

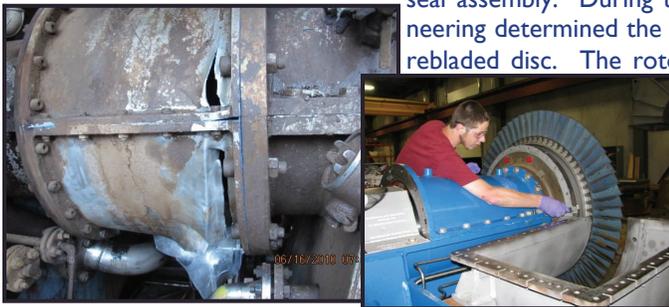
A major domestic refinery experienced a failure of their FCC expander resulting in the shutdown of the power recovery train. RMS was contracted to repair and rebuild the unit on an emergency basis. RMS responded to the emergency rebuild with 24-7 support from engineering services, manufacturing and field services to provide the refurbished rotor, bearing and seal assembly. During the initial inspection of the spare replacement rotor, RMS engineering determined the rotor disc was not suitable for service and would require a new rebladed disc. The rotor rebuild and refurbishment of the bearing and seal assembly, along with a rebuild of the exhaust casing to add stiffeners to eliminate casing cracking during operation were completed at the RMS manufacturing facility. In addition, a new coupling guard was fabricated and machined. Field service was provided to reassemble the expander and rework the intermediate casing and exhaust transition piece. RMS completed the entire scope within the customer's turnaround schedule.
