THE FINISH LINE

RMS EXPANSION FINISHES IN TIME FOR INFLUX OF EXPANDERS

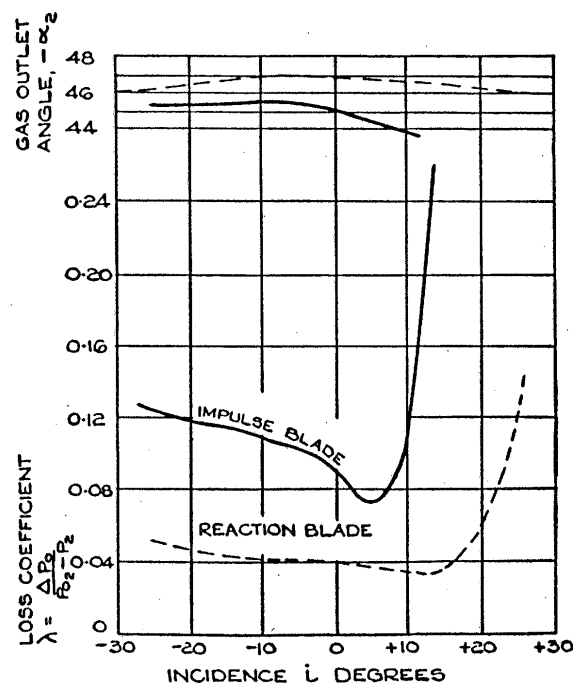
Figure 2

Reaction style blade profiles are designed with the ability to withstand a wider range of incidence without negatively effecting losses. This is due to the flow acceleration through the stages. The variation of profile losses against the angle of incidence range for impulse and reaction turbine blades can be seen in Figure 2.
