COOPER RF2B - 24 REFURBISHED AND SEALS UPGRADED

By Tom Keating, PE

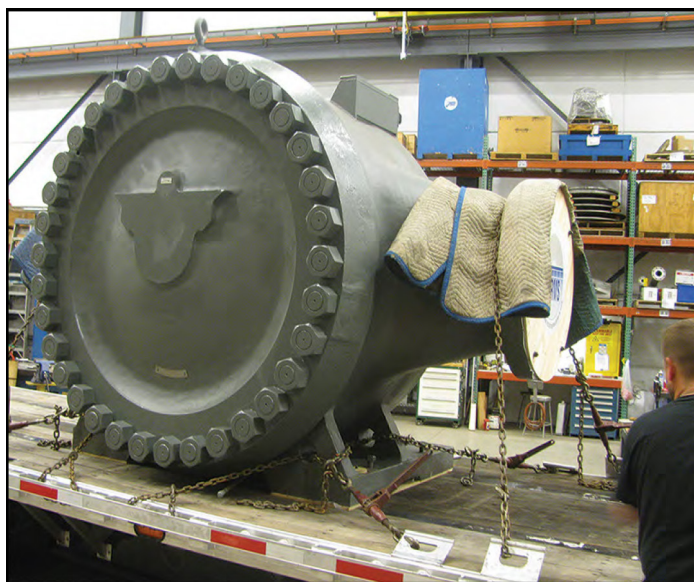
Figure 1

A Midwest utility company had its Cooper RF2B-24 two stage centrifugal compressor refurbished and the seals upgraded by RMS. The compressor is used in booster service primarily in the winter months, with outage availability in the summer to late fall. RMS assisted this customer with a bearing upgrade in September 2008, which addressed repeated bearing failures. In September 2015, RMS renewed the rotor to the customer's specifications and made recommendations for upgrades and repair for a future outage. This led to an award to RMS in June 2016 to refurbish the entire compressor at its Bethlehem shop and to design, manufacture and install an upgraded seal package.

It was noted that the compressor casing had been in place for about fifty years with only routine maintenance, so RMS did a complete teardown, blast clean and paint job. The compressor's o-rings, gaskets, labyrinth seals and fasteners were replaced. The suggested rotor repairs were performed: a new main shaft was provided, and impellers were re-bored and treated with an anti-corrosion coating. As a part of the seal upgrade, a Rotordynamic analysis was performed which confirmed the rotor's stability and predicted long term reliable service at design conditions.

RMS precision balanced the rotor to API 687 standards and fully assembled the compressor and then readied it for its trip back to the utility. The compressor was reinstalled by RMS Field Service personnel who had supervised its removal from site, ensuring that the compressor was exactly and efficiently positioned as before.
