# CUSTOM TAILORED COUPLING GUARDS

A Midwest refiner recently performed coupling replacement on their FCCU power recovery train. The machinery in the train includes four bodies: a GE steam turbine, an IR4013 axial compressor, a Westinghouse induction motor-generator, and an IR E-148 expander. The new Goodrich diaphragm couplings have substantially larger hub flange diameters requiring new coupling guards to suit. RMS was selected to provide the new guards complete per API and the end user's own engineering standards.

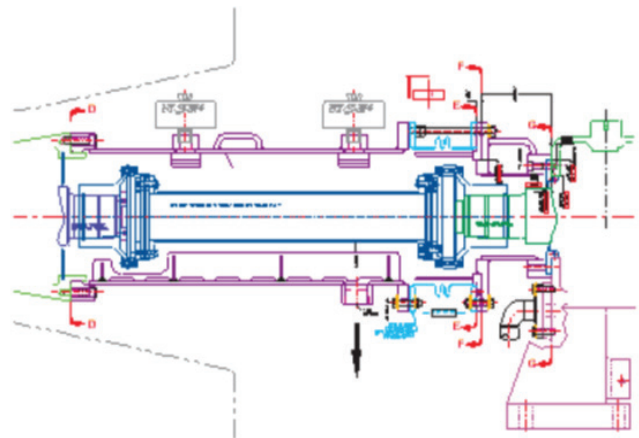
The guards were installed in September and are operating very satisfactorily per design intent.
