# ONE BIG AXIAL

In October 2018, RMS performed a turn-around for an FCC unit main air blower (axial compressor) of a major US refinery. This Allis-Chalmers compressor operates as a part of a Power Recovery Train and is rated for 203,000 ACFM. To put it in perspective, this compressor can change out the air inside the New Orleans Superdome football stadium in about 10 hours.

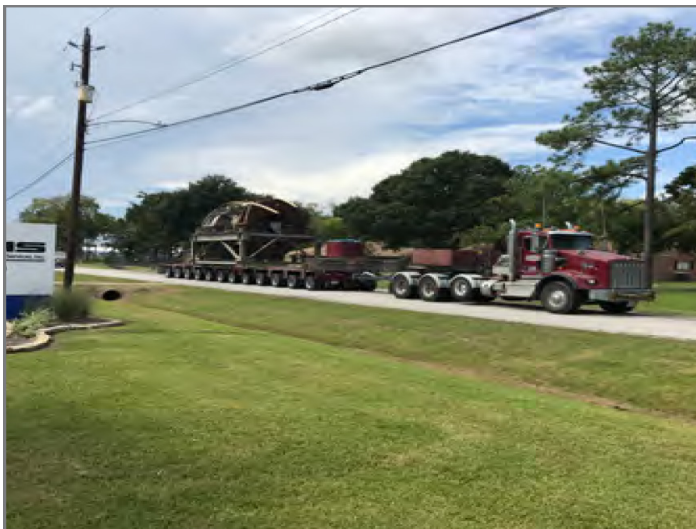
Figure 1

These units are typically turned around on-site, but due to the heavy corrosion on the inlet casing it was decided to perform the work in RMS Houston facility. This would enable RMS to abrasive blast the compressor casing and coat it with heat-resistant paint to prevent further deterioration.

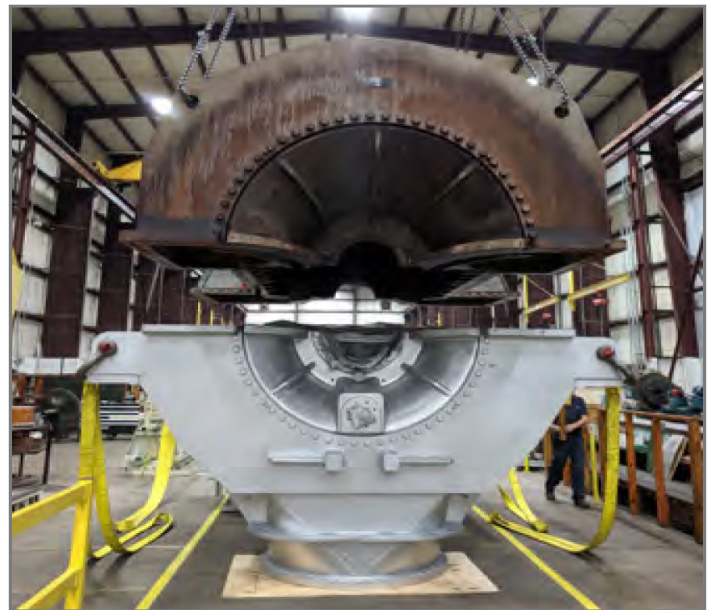
Figure 2

One of the highlights of the turnaround was discovering that some of the clearances between the overhauled rotor to the stator casing were less than specifications. Communications between RMS engineering and the customer representatives led to a decision to tip grind the blades, and highspeed balance the rotor (again). With efficient planning and implementation, only two additional days were added to the schedule.

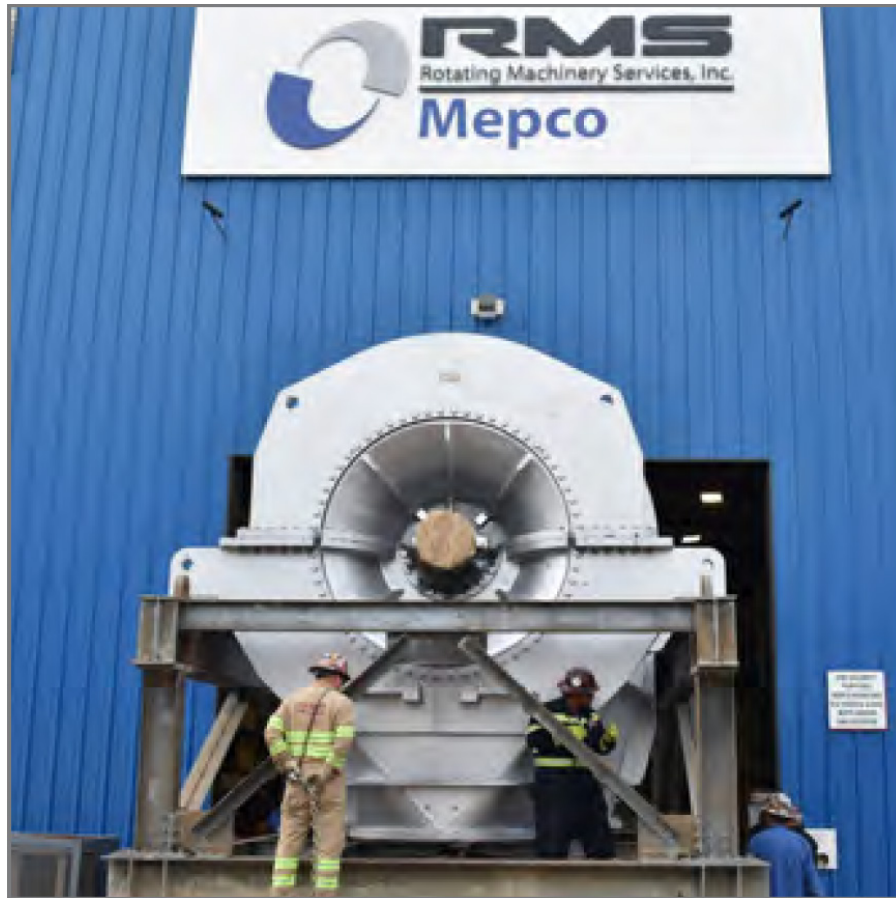
Figure 3

The compressor left RMS facility on-schedule, looking brand new, and has been successfully in operation since. The spent (old) rotor and stator assemblies are currently at RMS Bethlehem location to undergo inspections and design upgrades. The typical design upgrades for these type machines increases their reliability, maintainability, and manufacturing accuracy.
