OVERHAULING SOME HEAVY IRON!

By Robert J. Klova, PE

A major North American utility recently awarded RMS a contract to inspect and overhaul a large Worthington ER-224 Expander. In modern terminology, these units would be classified as aero-derivative power turbines, as each expander-turbine is driven by two Pratt & Whitney GG4 gas generators. Expander shaft output is approximately 40 MW (54,000 hp). These turbines are typically installed in peaking power service, and have been in operation since the late 1960's. Two turbines were shipped to RMS with the goal of combining the most serviceable components (after repair) to assemble one machine suitable for long-term, reliable operation.

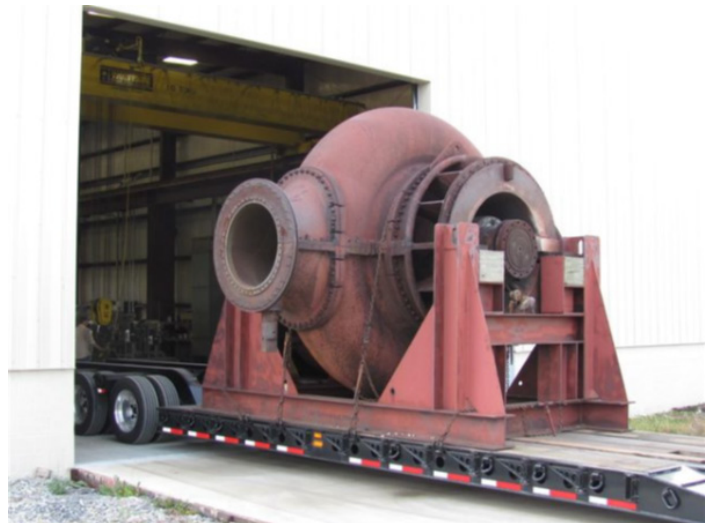
As can be seen in the accompanying photograph, these units are quite large by power turbine standards, and weigh over 70,000 lbs. Construction is also very unique. A GG4 gas generator is mounted to each side of the large annular casing at the center of the machine, and feeds the power turbine with high temperature, pressurized (1190 degF, 44.5 psia) gas. The annulus routes the inlet gas around a radial array of inlet guide vanes (stators), which direct the gas into a cavity feeding the center of a double-flow, two-stage (four stages total) rotor. The radial stator and the rotor can be seen in the second photograph. Gas then exits from a diffuser at both ends of the turbine and into a single exhaust plenum (not shown) and stack to atmosphere.

- Weld repair rotor blade foreign object damage (FOD).
- Weld repair stator foreign object damage.
- Weld repair or blend casing cracks and re-heat treat.
- Remachine casing
- Replace all high temperature fasteners
- Replace bearings
- Replace shaft seals
- Replace honeycomb tip shrouds
- Reassemble rotor and balance
- Reassemble complete unit, reestablishing all critical fits and clearances
