STEAM TURBINE OVERHAUL FOR STEEL INDUSTRY CUSTOMER

RMS was tasked with performing a Phase 1 inspection on a spare steam turbine rotor used in a steel mill blast furnace blower.

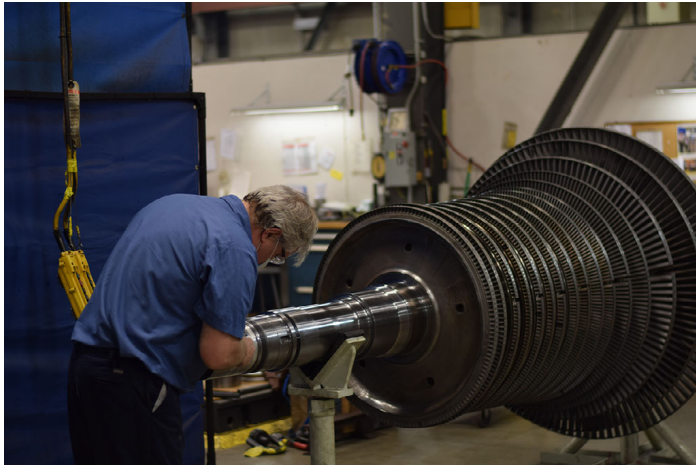
Figure 1

The rotor was from a 1947 vintage DeLaval condensing turbine. Visual and NDT inspection revealed several blade rows required replacement or repair while runout indications showed the rotor to be bowed.

a built-up rotor, discs on shaft, the conditions of the Phase 1 inspection required a Phase 2 disassembly inspection to investigate and rectify the bow.

After obtaining the critical dimensional information for the rebuild, the rotor was destacked. Indication of the bare shaft revealed it to be the source of the rotor bow. In addition, the blade rows to be replaced were found to be corroded into the discs so thoroughly that replacement of the discs was necessary.

RMS performed all reverse engineering and design work to restore the rotor to its former glory with new blades, discs and shaft. The effort was accomplished with skilled reverse engineering performed by craftspeople and designers with decades of experience caring for turbomachinery of all sizes and manufacturers.

The rotor is undergoing final inspections and at-speed balance before being returned to the customer for another 73 years of reliable service.
