COMPLETE START-TO-FINISH SUPPORT - TIMELY COMPRESSOR OVERHAUL BY RMS GETS PLANT UP AND RUNNING AT FULL CAPACITY.

By Ryan Rottier, Product Director - AC Compressor Centrifugal Compressors

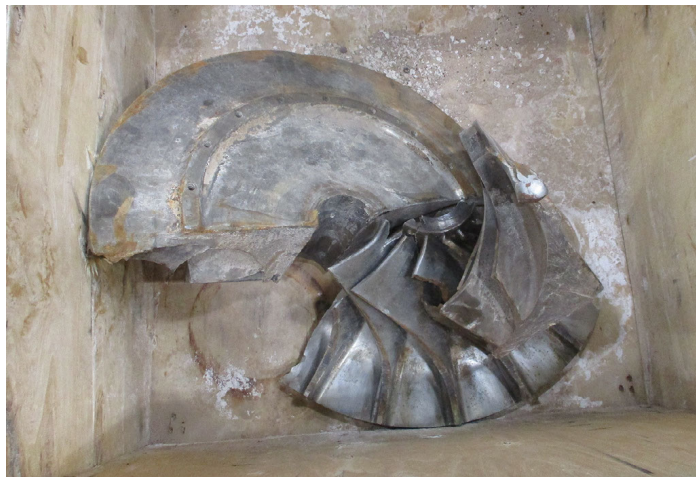
Figure 1: The inlet nozzle, casing, and impeller were all damaged beyond repair.

The customer has two compressors that run in parallel, pulling steam off an evaporator as part of a sodium sulfate refining process. The impeller on one of their two AC Compressor D16JR compressors split in half, causing a catastrophic failure of the compressor. The inlet nozzle, casing, and impeller were all damaged beyond repair. There were no warning signs (vibration, performance change, etc.) indicating this failure was imminent, so the customer was caught off-guard. With one of the compressors down due to the failure, their production rates reduced significantly.

Fortunately, the customer had a spare rotor from the failed compressor as well as a surplus D16JR compressor on-hand. This surplus compressor was a little different than the compressor that failed, however. RMS engineers evaluated the surplus compressor's design and compared it against the original compressor to determine what modifications were needed to make a suitable replacement for the failed compressor. The primary difference was in the inlet nozzle design, but RMS was able to re-design the surplus inlet nozzle and have it machined to fit and work with the spare rotor from the failed compressor. The RMS Engineering team quickly released a repair drawing, and the RMS Sourcing team was able to work with a machine shop in Houston for a quick turnaround.

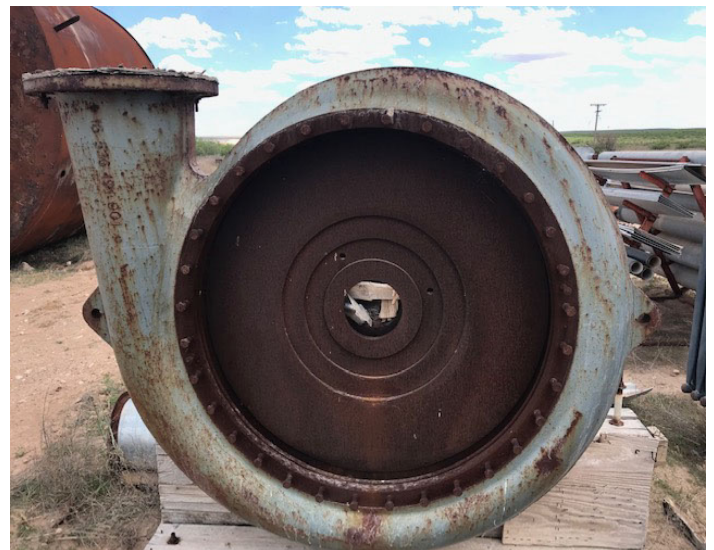
Figure 2

Besides the fit, the other area of concern with the surplus compressor was its condition, since it had been sitting in the elements for several years. The bearing housing, in particular, had a lot of rust and looked like it may need significant work to be usable, which was confirmed once RMS cleaned and inspected it.

Significant corrosion was present on the surplus unit's bearing housing, so RMS worked with the customer to evaluate the bearing housing from the failed compressor. Upon inspection of the failed compressor's bearing housing, significant cracks were found, however this bearing housing was still in much better shape than the surplus compressor bearing housing. The RMS Engineering team quickly developed a repair plan for the failed compressor's bearing housing, and the RMS-Mepco machine shop was able to complete the repair in time for compressor assembly as planned. Other unplanned work included rebalancing the rotor and repairing cracks in the backplate. All of these unplanned repairs were addressed quickly by the Engineering and Houston Operations teams.
