# RMS OVERHAULS AXI OFS MACHINE FOR PETROCHEMICAL CUSTOMER

*By James Wieder and Jeff Lovelady*

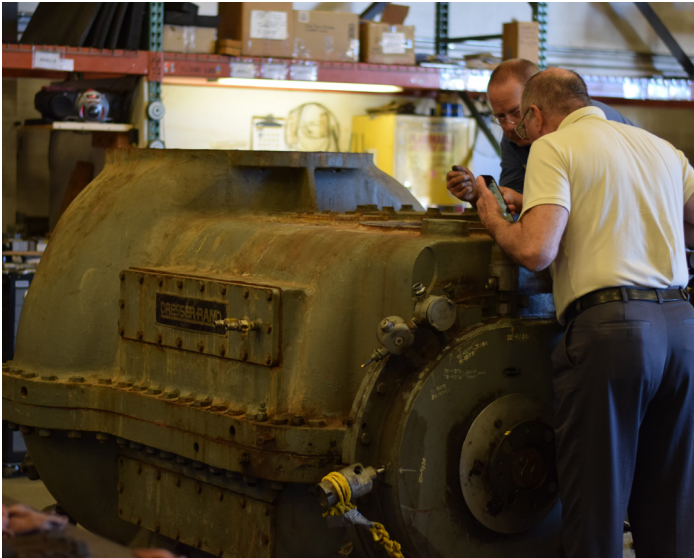
The full inspection revealed several repair opportunities. The RMS team identified a water leak at the split line seal between the cooling water connection between the upper and lower halves as the main cause of the failure. Water entered the lube oil system, which

negatively affected the oil's ability to properly lubricate the bearings causing the steam turbine to trip leading to a plant shutdown. At the split line, RMS identified, corrosion at the O-ring location, a Teflon ring with no backing support, corrosion on mating seal surface on the upper half joint face, and Oxidation path on horizontal joint clearly showed the leak path to discharge end oil drain.

With the inspection work completed, the RMS team got to work on the repairs required to get this Dresser-Rand Axi 630HS165 Oil Free Screw Compressor back into service. First, the O-Ring joint was opened up so the RMS team could create a counter-bore for (4) steel disks to be inserted into both upper and lower half casings. The Steel disks were inserted into the counter-bore in the casing halves and seal welded into place. The lower half disks were machined flush with horizontal joint and the O-Ring groove was machined into the lower half disks. Finally, the upper half casing was recut to eliminate corrosion to the seal surfaces around the O-ring seat.

The support areas between the bearing and seal fit on each end of the machine were welded and the upper and lower casing horizontal joint surfaces were milled to remove high spots. Rotor bearing journals were ground to remove any damage from lube oil contamination and new bearings were manufactured to meet the original bearing clearance specification.

After all repair work was completed, RMS Hydro tested the water jacket to verify the horizontal joint repair, with newly inserted disks to contain the O-rings, passed the required specifications. With a successful hydro test completed, RMS got work assembling the compressor.
