# PIPELINE COMPRESSOR JOURNAL BEARING FAILURE

By Anthony Rubino, P.E.

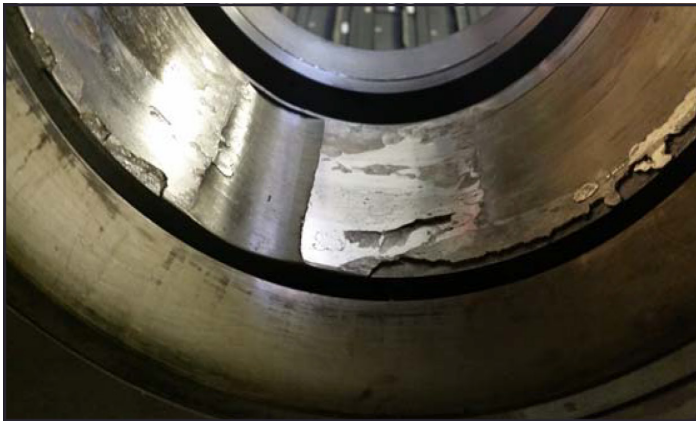
Figure 1

An operator of a gas turbine driven pipeline compressor noted excessive oil usage at the impeller end journal bearing. Rotor vibration was typical and bearing temperature was typical at approximately 180F. Journal bearing failure was discovered after disassembly. The damage to the bearing indicated Babbitt fatigue, separation and melting. Loss of adhesion and molten Babbitt can be seen in the photographs. Most of the damage was located at the outboard (i.e., impeller) end of the bearing where the oil is contained by a floating

seal. A failure investigation was not performed but excessive oil flow through a worn floating seal was suspected to be the root cause.

The compressor typically operates in cyclic service subjecting the bearing to numerous starts and stops, as well as startup and shutdown vibration transients. The bearing had operated for approximately seven years. Fortunately, there was no damage to the shaft and the unit was restarted after installing a spare bearing.
