STEAM TURBINE DEPOSITS

By Sydney Gross

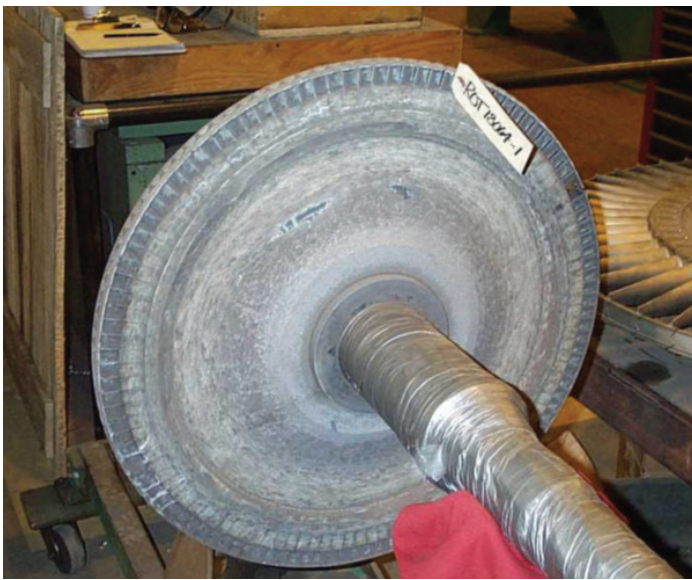
Steam turbine deposits are a direct result of boiler water impurity from all sources of water that enter the system such as feed water, make up water and attemperation. Impurities may also originate internally from paints, sealants, gaskets, blasting media, corrosion products, etc. Often, impurities will settle in the drum only to be stirred up and carried over in high concentration during boiler upsets. Although these impurities may be in low concentration in the steam, a few parts per billion (ppb), their concentrations can become much higher as they deposit in the turbine. The most common impurities found in steam are sodium chloride, silica and iron oxide.

Deposits form on valve parts causing sticking and in seal areas between the rotor and stationary seal causing wear damage to the rotor, seal or both. Deposits form on the rotor discs, blades and shrouds resulting in pitting corrosion, stress corrosion cracking and corrosion fatigue. In more severe instances, rotor to stator clearances may be closed and rubbing can occur. Deposits also adhere to the flow path components, diaphragm and nozzle vanes and rotor blade surfaces, thus reducing flow area and increasing surface roughness resulting in reduced capacity, reduced efficiency and higher thrust loading. Uneven deposits on the rotor can result in elevated vibration levels.
