TURBINE STEAM PURITY

By Scott MacFarlane

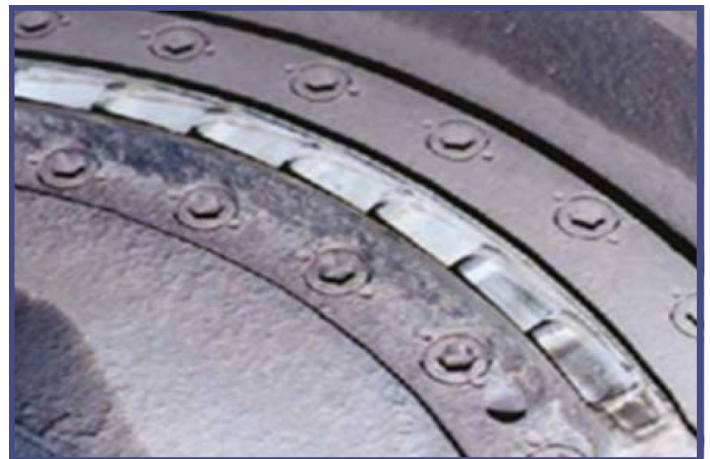
its operating temperature, the condensate evaporates leaving concentrated contaminants on the surface. Unfortunately these concentrations of contaminants mainly form on hard to reach surfaces where the steam's flow cannot provide a washing effect. These surfaces also happen to be heavily stressed areas which will increase the chances for stress corrosion failures. Rotor blades and vanes manufactured from an AISI 403 12%Cr stainless steel is the most commonly used material to prevent these failures. Other potential hazards that are associated with the steam's purity come in the form of erosion, particle accumulation, flow obstruction, high thrust loading and sticking of valve stems. An example of flow path deposits from steam impurities can be seen in the photograph.

Reduced steam purity can cause internal components of the turbine to accumulate deposits and cause severe corrosion. The more serious types of corrosion are stress corrosion cracking and corrosion fatigue. Stress corrosion cracking is the collaboration of corrosion and mechanical stresses to cause a failure by cracking the surface. Corrosion fatigue is the collaboration of corrosion and alternating or cycling stresses that causes a rupture of the surface, which in turn accelerates the corrosion. These specific cases of failure are particularly detrimental during cold startups due to large condensation of steam. When the turbine reaches
